**Demonstration and M&V: Commercial
Heat Pump Water Heating System
using the Mitsubishi HEAT2O in Origin
by Steffes Plug-and-Play Package at
Bayview Tower, Seattle WA**

March 2022

Ecotope Inc.

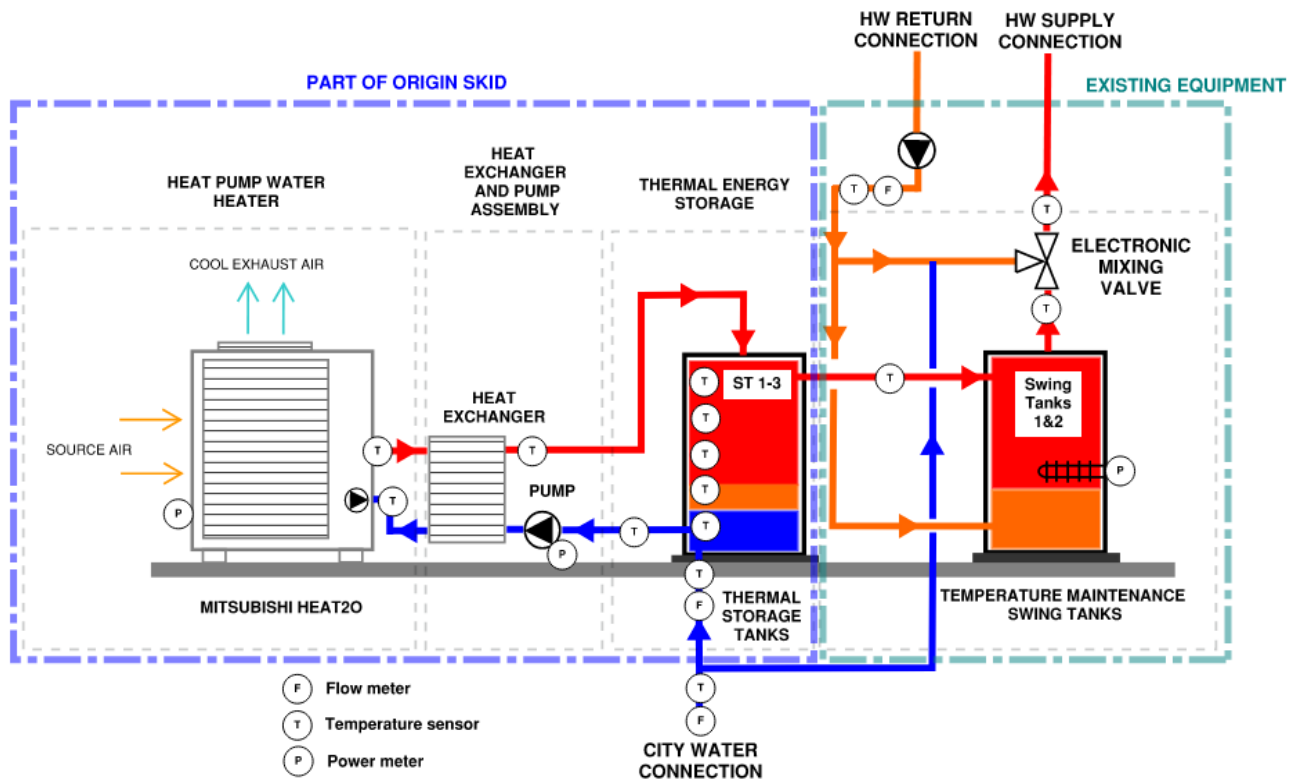
Figure 1. Origin fully packaged system simplified schematic (with monitoring points)

Figure 1 shows the major components in the packaged system. The QAHV System Development and Applications Testing report describes the system in detail.

Monitoring points are displayed in Figure 1. Data was delivered hourly to the study team's servers and compiled daily. The study team set up an online tool to view the monitored points from the CHPWH system, as well as calculated values like COP and heat output. This data was automatically updated nightly, allowing the engineers and installers commissioning the project to quickly receive feedback on initial system operation. Partial data has been collected and was available through the online tool² beginning August 2021, with the full suite of data points initiated in September 2021.

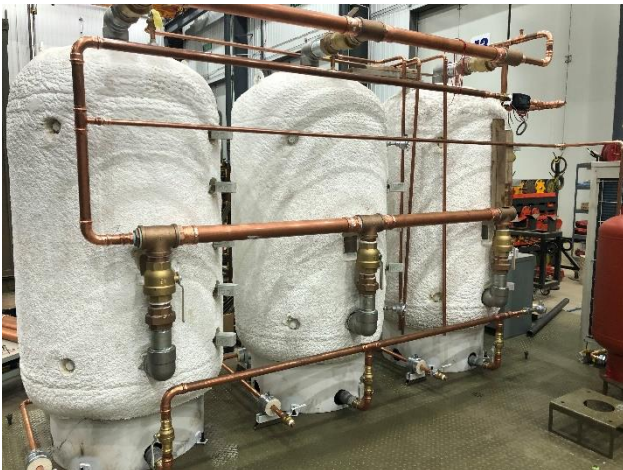
Figure 2. Storage tanks and piping during initial skid assembly. Photo credit: Steffes.

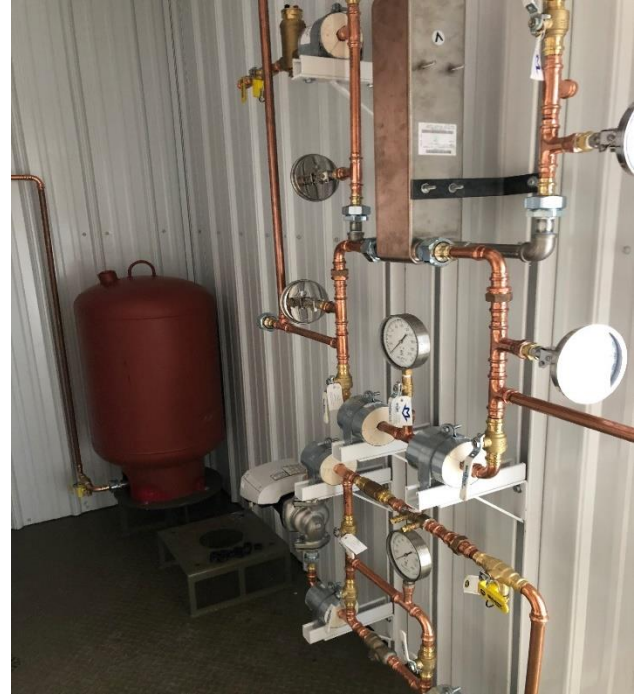
Figure 3. Secondary loop heat exchanger before pipe insulation was installed. Photo credit: Steffes.

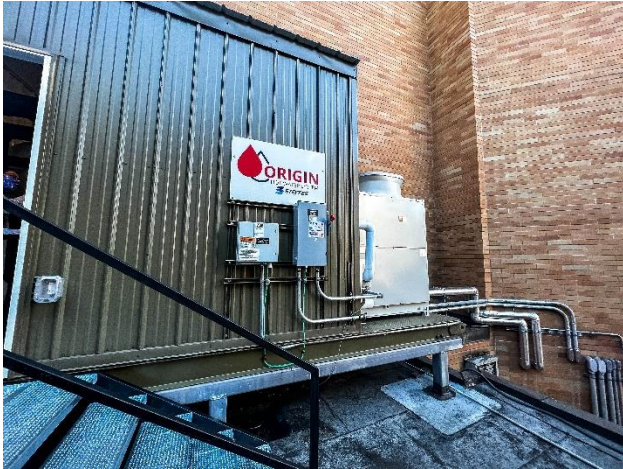
Figure 5. Origin skid installed at Bayview Tower with HEAT20 external to skid enclosure. Photo credit: Blue Fern Productions.

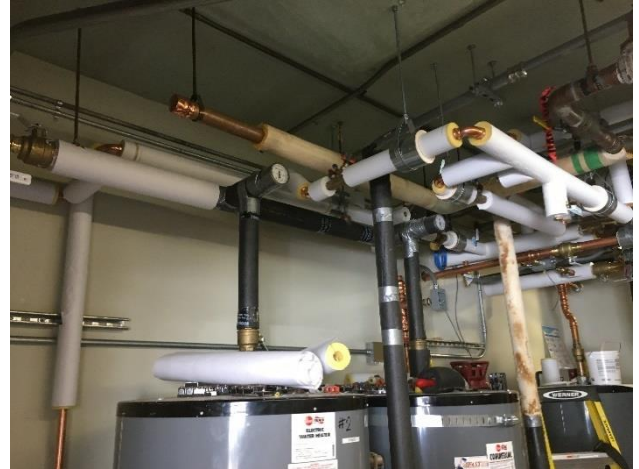
Figure 7. New piping in mechanical room connecting to existing electric resistance water heaters (during insulation installation).

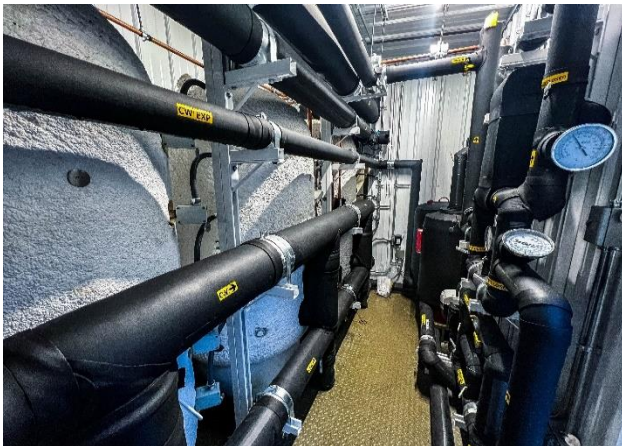
Figure 6. View inside rooftop skid shed with storage tanks (left) and secondary loop heat exchanger assembly (right). Photo credit: Blue Fern Productions.

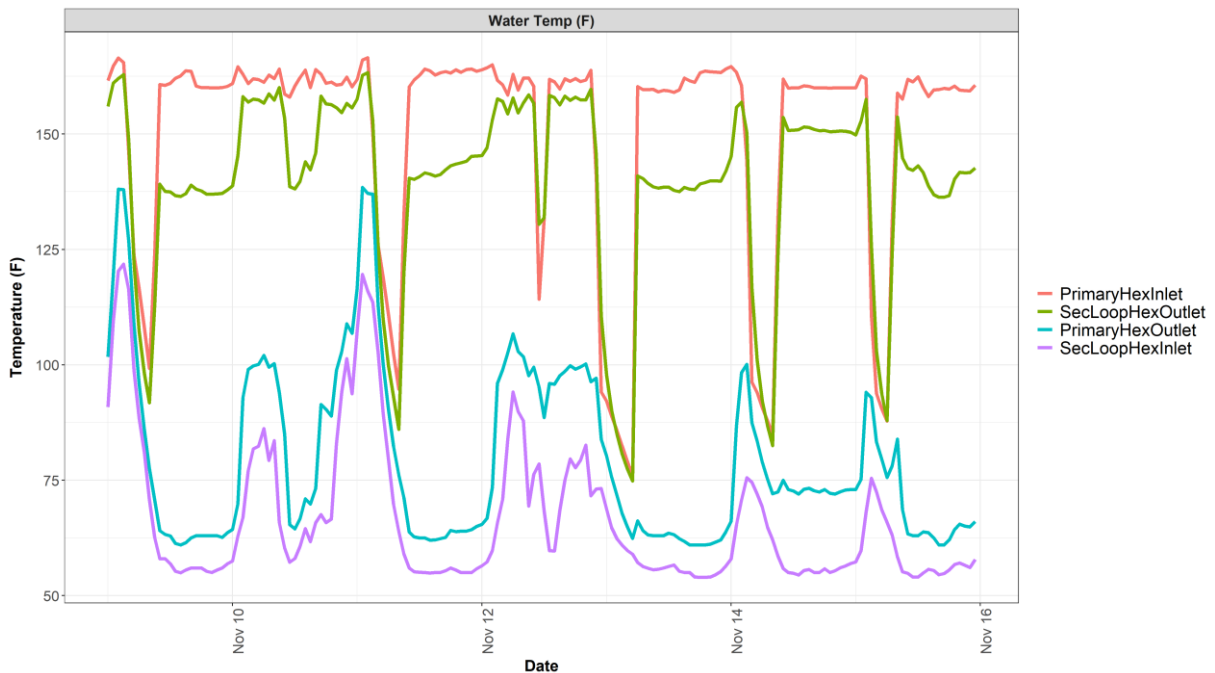
Figure 11 shows more detail for several heating calls before and after the controls-point changes on November 12 and before the heating mode was changed again. Note that temperature run-ups, visible in the increased PrimaryHexOutlet / HPWH inlet temperature at the end of a heating cycle, are much briefer in duration after November 12, which was the aim of controls points adjustments. This mode testing and controls and flow rate adjustments helped optimize the operations of the CHPWH at this site and increased

Figure 11. Detail of hourly inlet and outlet temperatures in November 2021

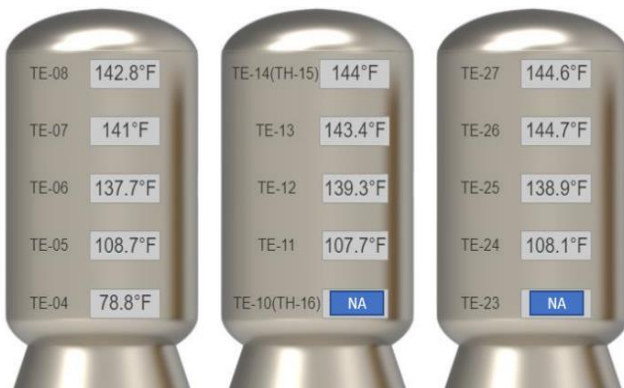
The study team observed that the parallel-piped storage design worked well and delivered consistent hot water to building occupants, suggesting that well-designed parallel-piped storage approaches are viable in HPWH system applications. Figure 12 shows a snapshot of the thermal storage system as shown by the METUS control panel interface. Although the figure can only show one moment in time, the tank was observed to be well-balanced throughout the monitoring period. The

Figure 12. Snapshot of temperatures in thermal storage system

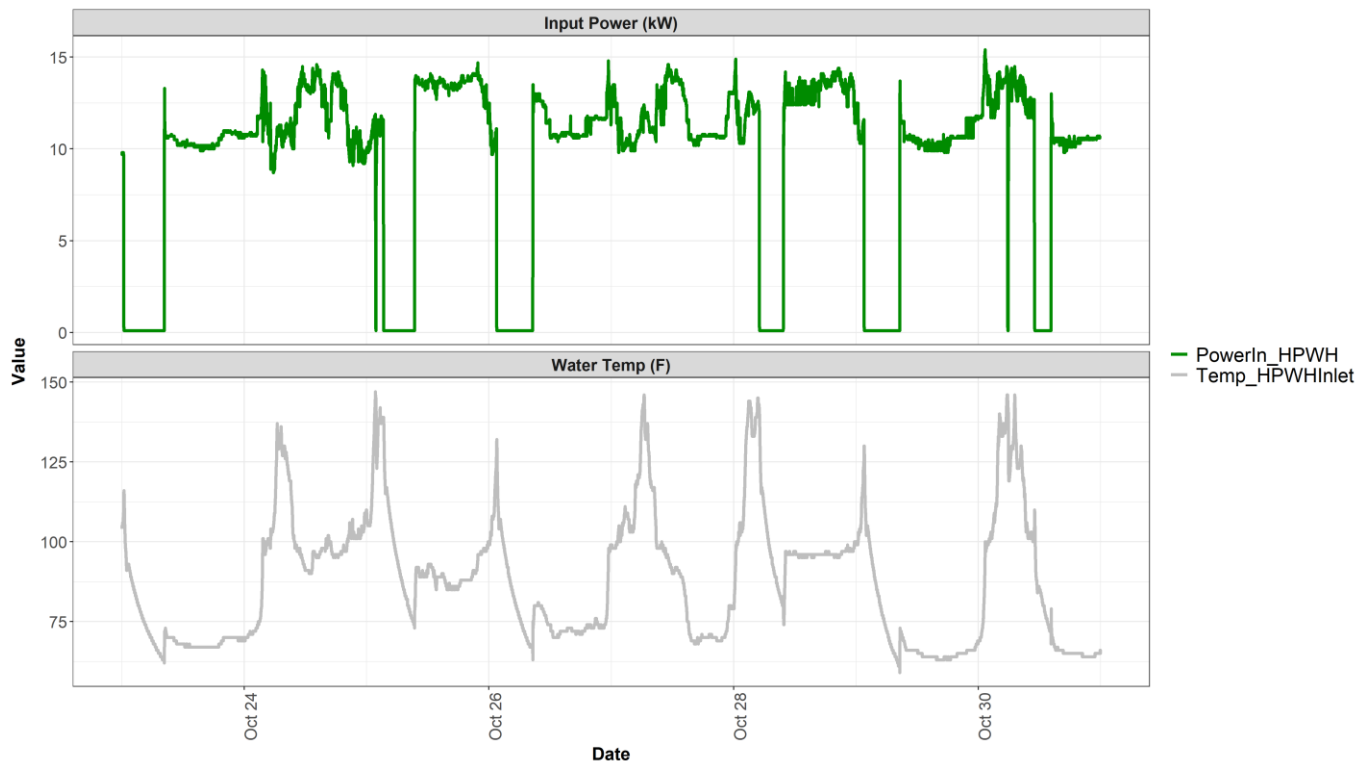
Figure 17. Heating cycle detail

Figure 17 shows both:

- Heating cycles > 36 hours of duration on October 23-25 and October 26-28
- HEAT2O stop-restart behavior the morning of October 25 and October 30, correlated with elevated inlet temperatures near the end of a heating call. Note, there are occasions when similarly elevated temperatures did not result in this behavior. In most cases, the secondary loop flow was also paused under these conditions, and it is possible that this was driven by secondary loop pump operation. The study team expects these instances to be resolved with the replacement pump.
