FREEDOM OF INFORMATION ACT PROGRAM

The purpose of this technical memorandum is to characterize the hydraulic conditions of Gibbons Creek in support of the restoration project. Hydraulic analysis compares existing (without project) and proposed (with project) creek conditions under a range of hydrologic conditions. The analysis is intended to support US Army

STEIGERWALD FLOODPLAIN RESTORATION PROJECT

Basis of Design Report
60% Design

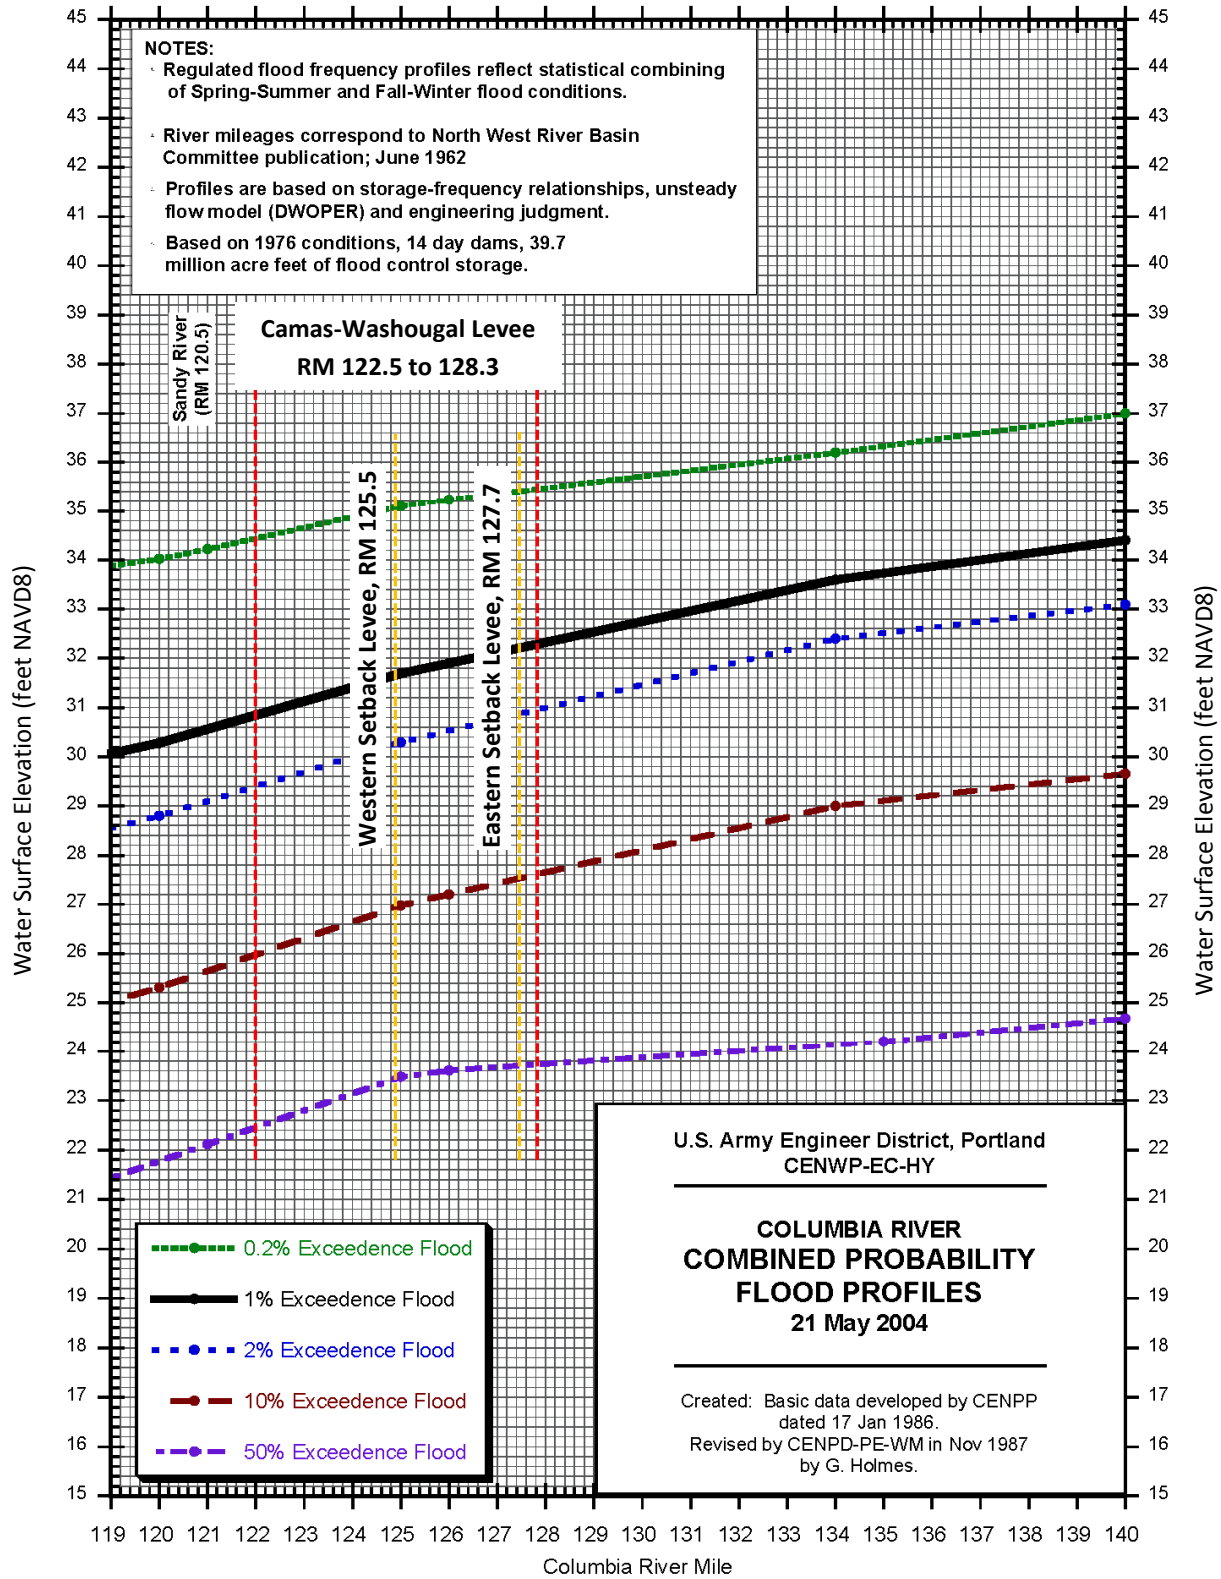
Figure 3
Combined Probability Columbia River
Flood Profiles.

After restoration, the Columbia River would flood into the Refuge during winter storm and freshet conditions. Columbia River flood levels are defined by the US Army Corps of Engineers (USACE) according to combined probability flood profiles (USACE 2007). Flood levels in the river at the Refuge are complicated because they are dependent on upstream flows from Bonneville Dam as well as other factors including varying tides downstream in the river-estuary, the Willamette River, and other tributary inflows such as the Sandy River (USACE 1989). The USACE flood profiles are based on observed water level data from stations along the river as well as hydraulic modeling. Flood water levels in the river at roughly the west setback levee and Gibbons Creek location (River Mile 125.5) are summarized in Table 2. The combined probability profiles are shown in Figure 3.

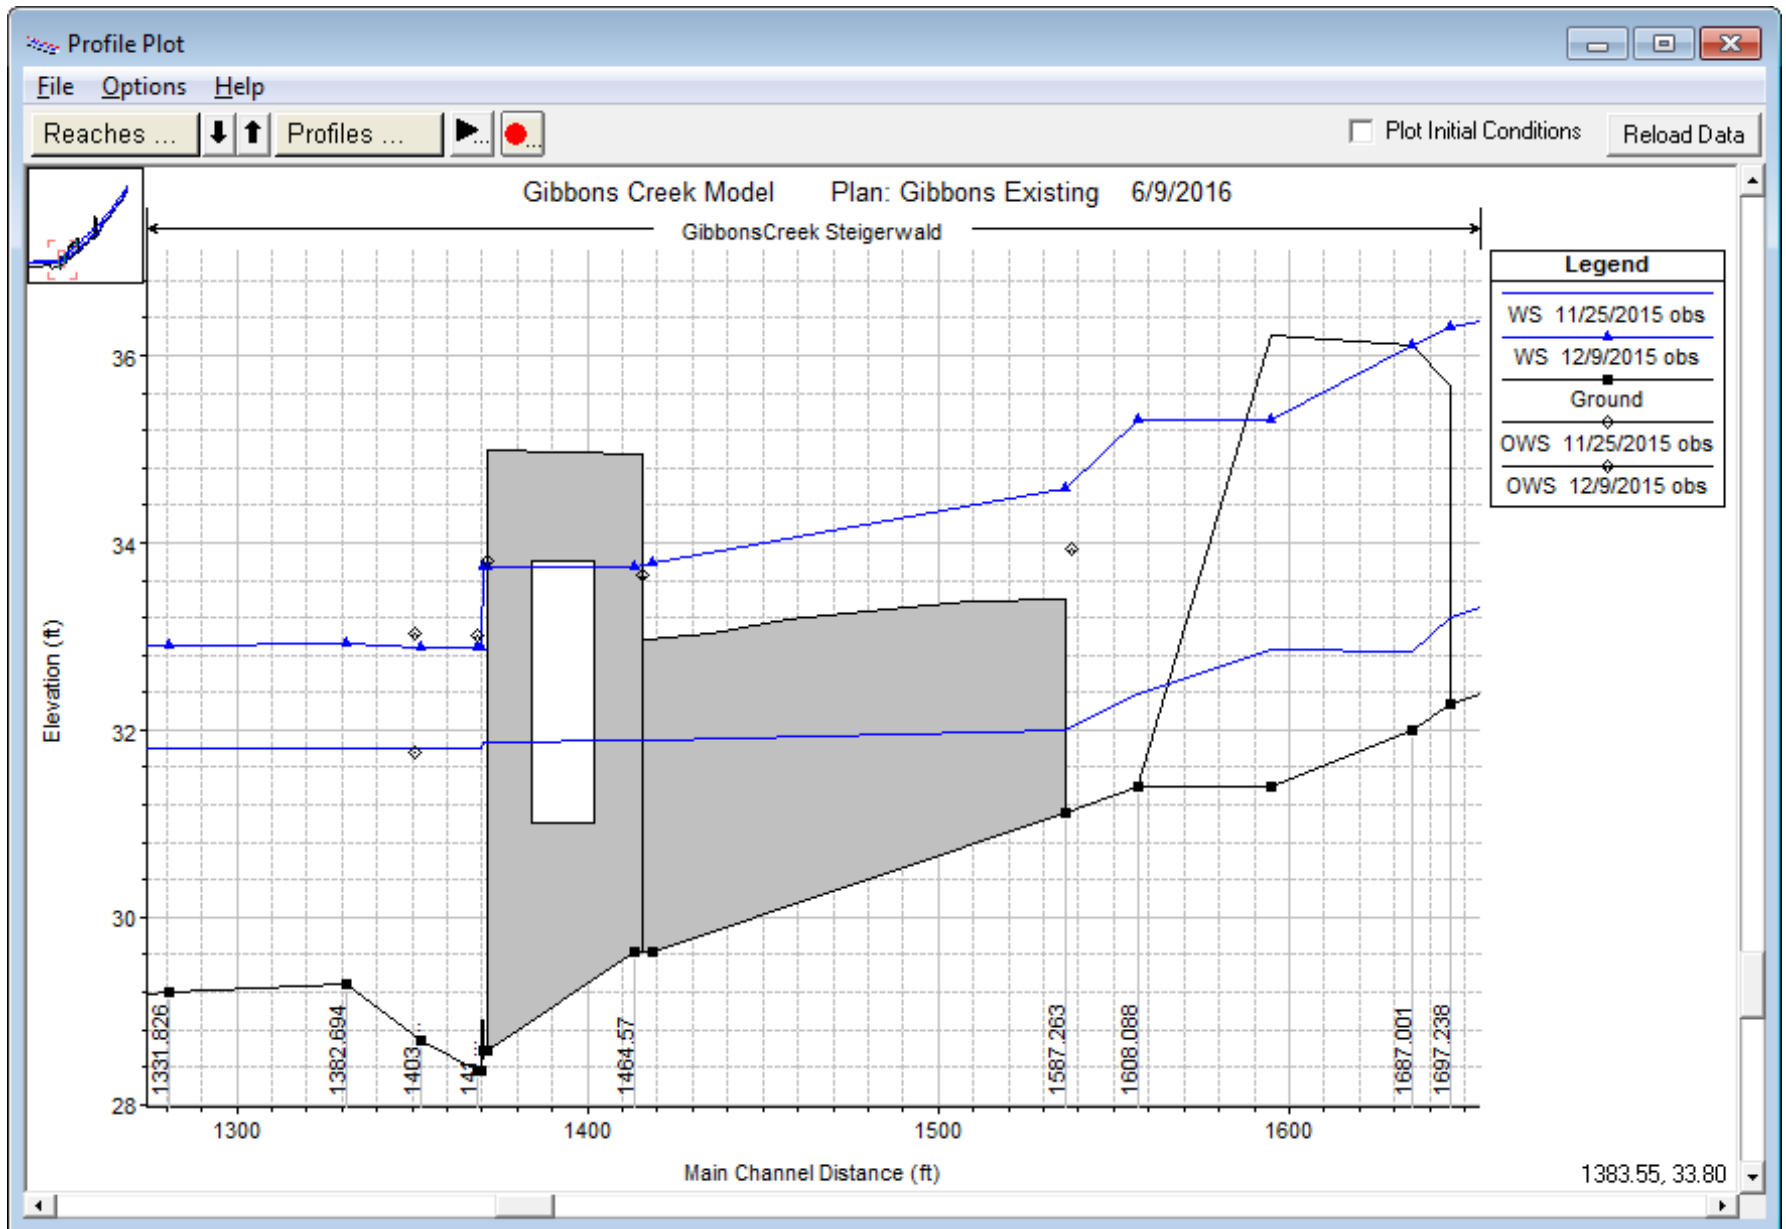
Figure 9

Calibration results are displayed in Table 7 and Figure 9. Simulated WSEs match observed water surface elevations within 0.16 feet (0.5% or less difference) at most of the calibration locations. Simulated WSEs at two of the calibration locations (upstream face of the SR 14 Bridge and at the upstream end of the concrete weir abutment wall) were higher than observed WSEs by 1.4 feet (4.0% difference) and 0.6 feet (1.9% difference), respectively. In general simulation and observed WSEs match well, and the calibration is considered good. At the locations near the bridge and upstream end of the overflow weir, the somewhat higher simulated WSEs might be considered conservative with respect to flood risk evaluations.

Comparison of Simulated Water Surface Elevation Profile Results to Observed Water Level Data.

The purpose of the model calibration was to demonstrate the veracity of the model under low and high flow conditions. The existing conditions HEC-RAS model was run using a 54 cfs low flow (11/25/2015) and a 705 cfs high flow (12/9/15) profile. For these profiles, observed water surface elevations at six locations (upstream of the SR 14 Bridge, between the SR 14 Bridge and the water control structure, and downstream of the water control structure) were used.

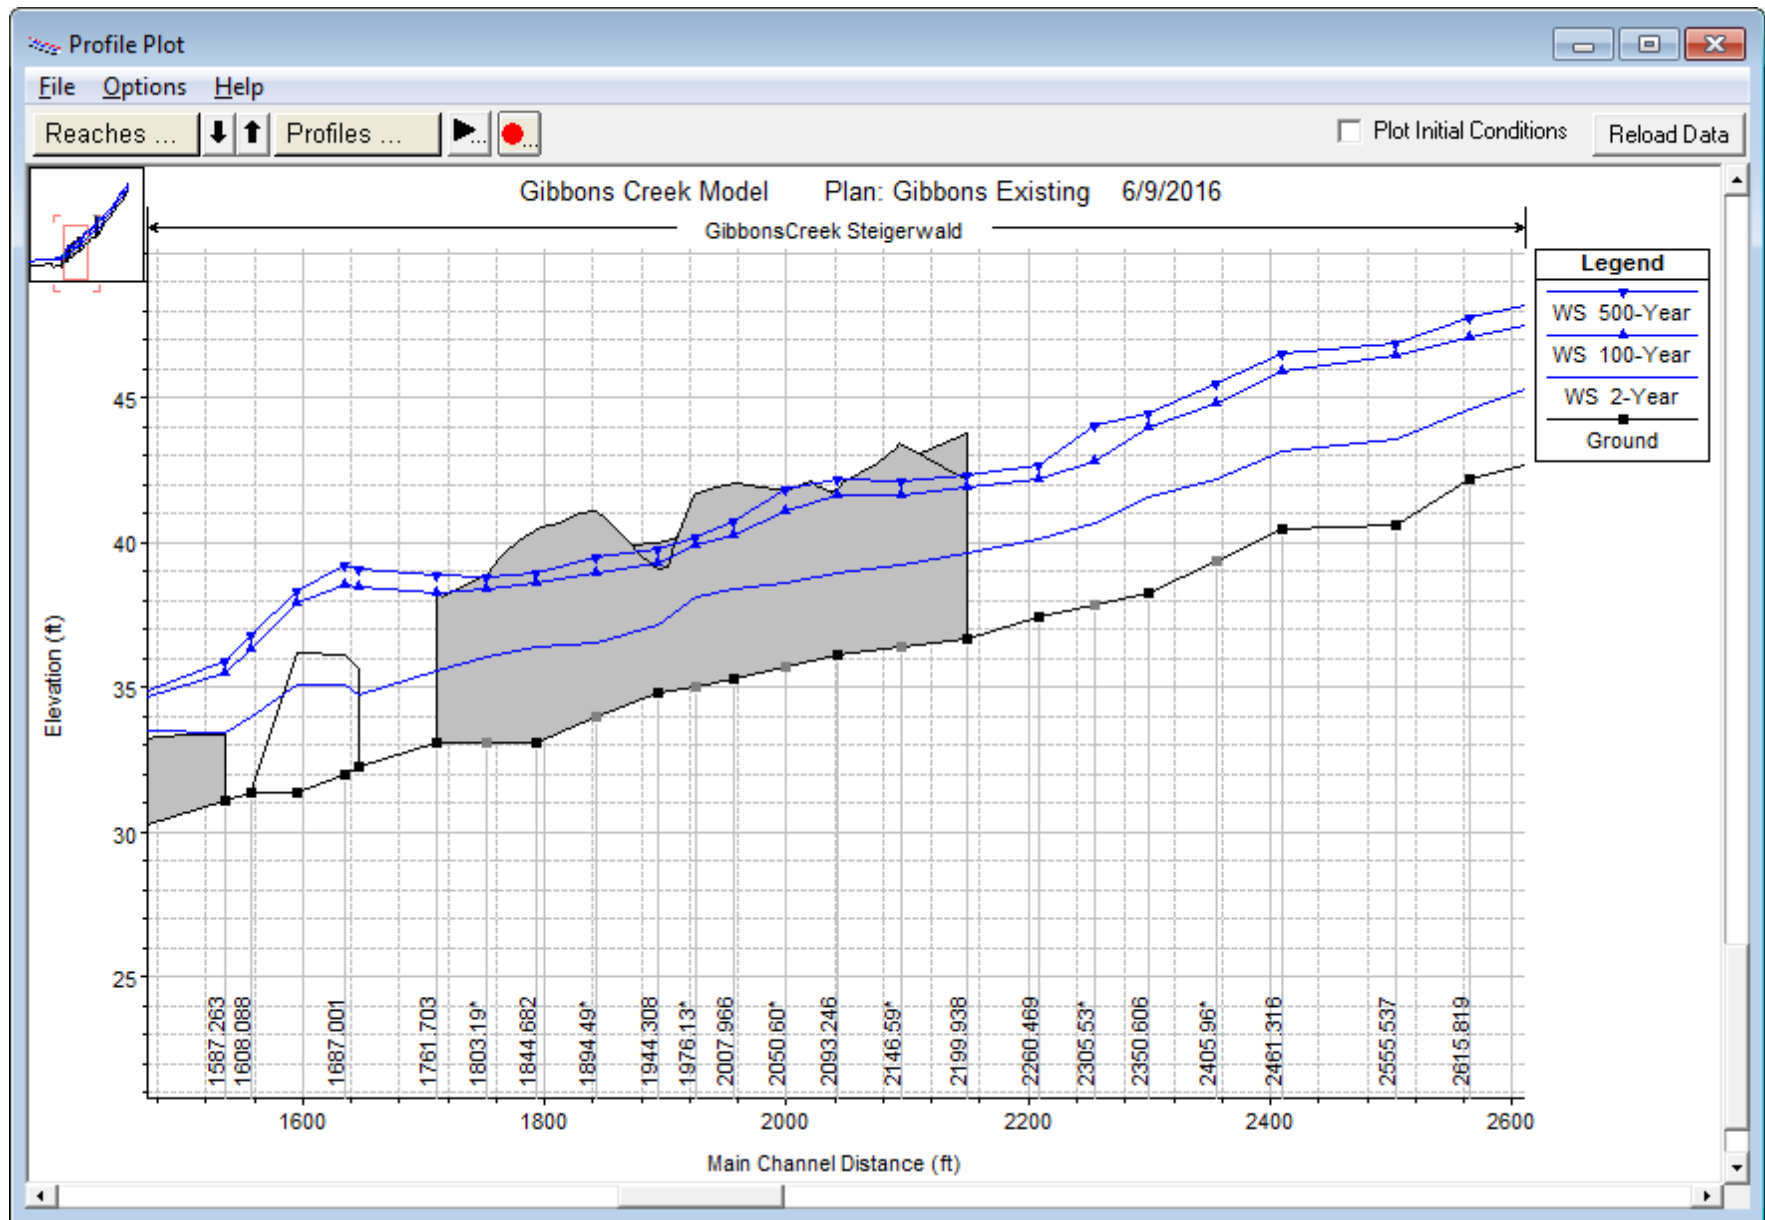
Figure 10
 Simulated Water Surface Elevation Profile Results
 Under Existing Conditions.

Existing and proposed conditions were compared under a range of creek flows from the 2-year to the 500-year event to generally characterize how the restoration project will affect the hydraulics of extreme flows in the creek. Results are summarized in Table 8, Figure 10 and Figure 11 (water surface elevation profiles), and Figure 12 through Figure 15 (cross sections). The summary table and figures highlight representative water levels (2-

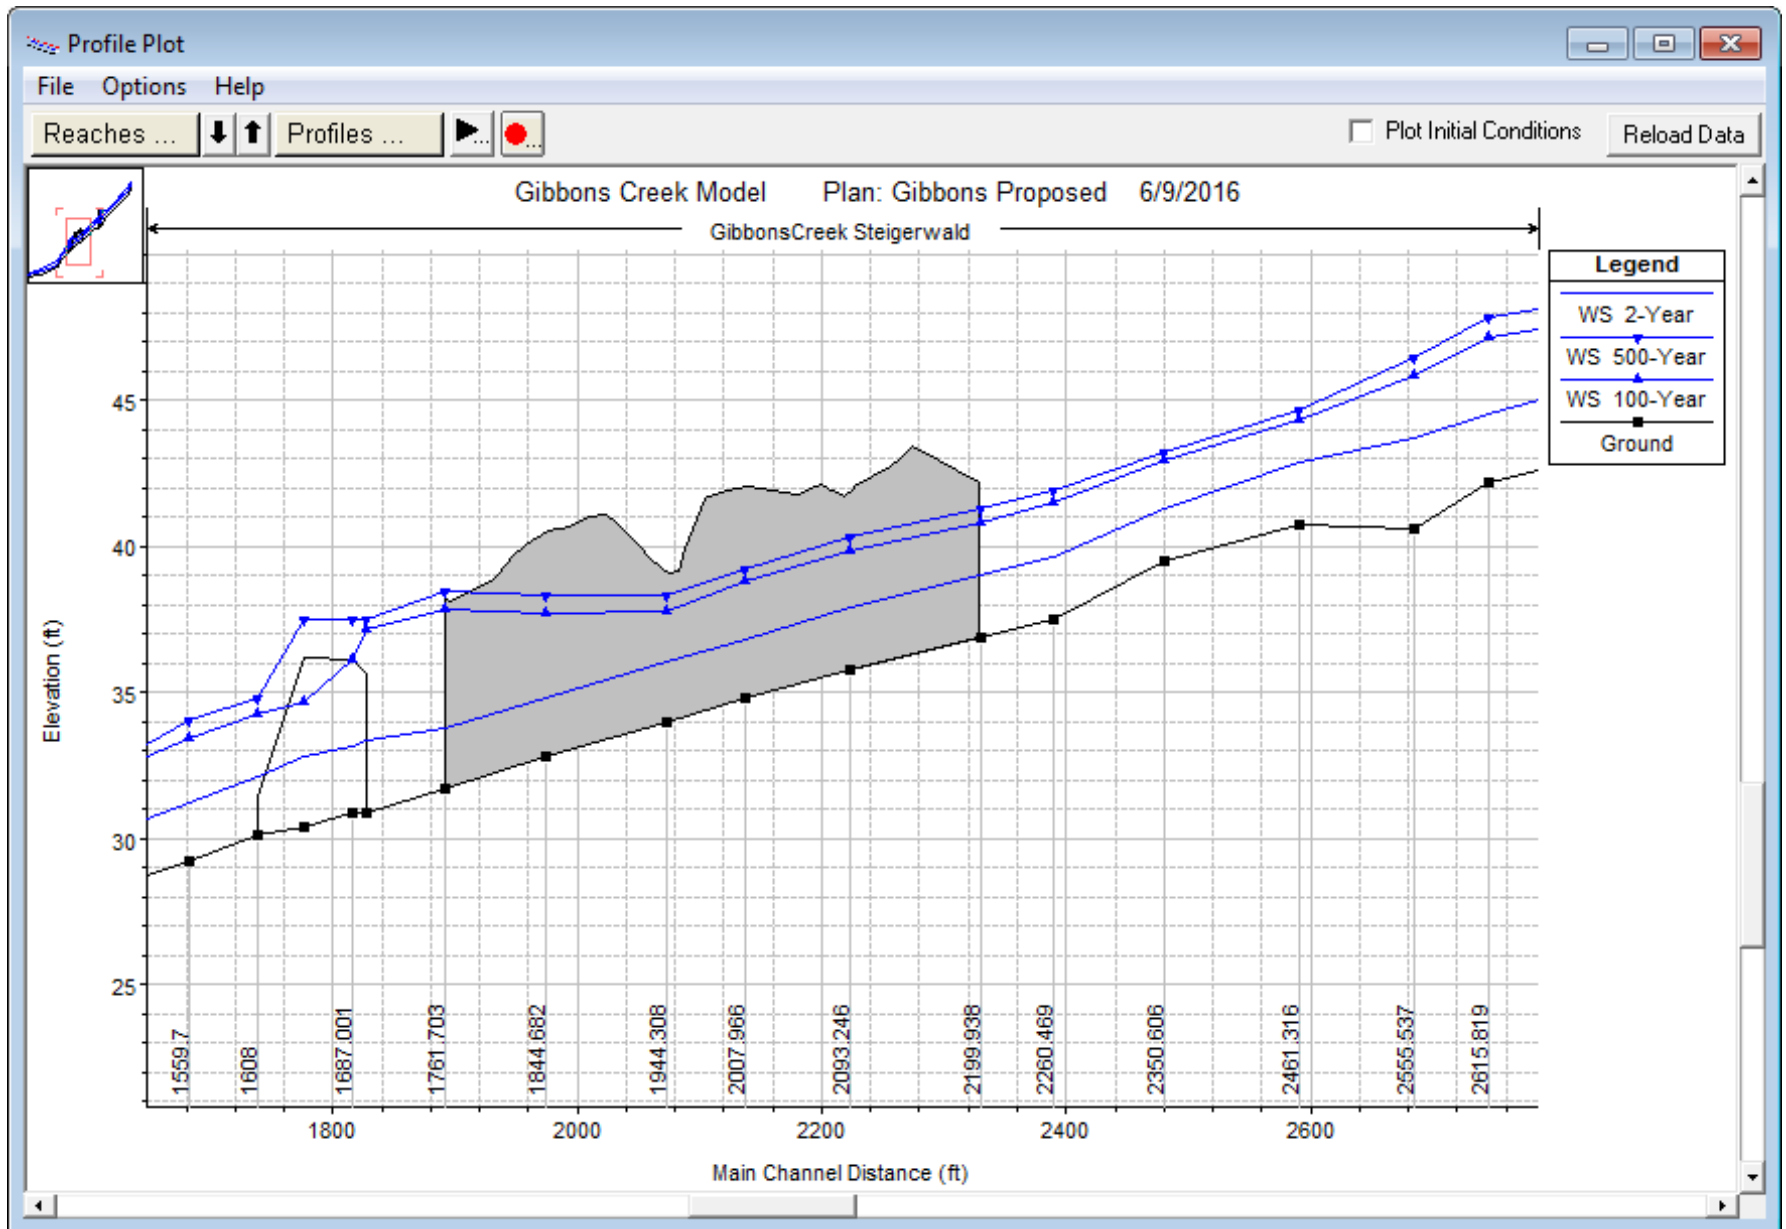
Figure 11
 Simulated Water Surface Elevation Profile Results
 Under Proposed Conditions.

From Table 8 simulation results show that water surface elevations (WSEs) decrease at all locations in the project reach under restored conditions. The exception to this is upstream of the restoration (RS 2615) where the model shows no change in water levels, as anticipated. The magnitude of the decreased WSEs ranges from 0 to over 2 feet, with the locations of largest decrease being downstream of SR 14 (due to diversion removal) and along the upstream end of the floodwall/berm near the private residence where the restored creek channel and floodplain significantly increase.

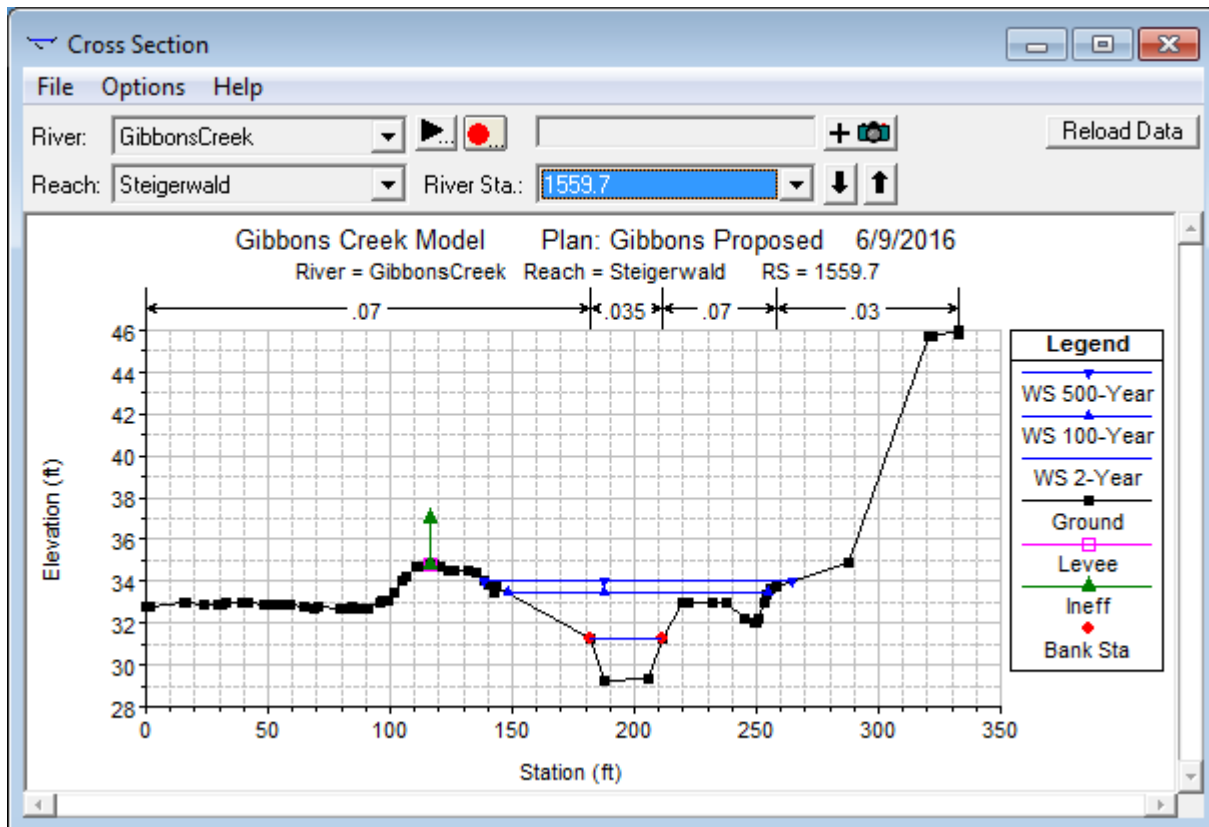
Figure 12
 Existing (Top) Versus Proposed (Bottom)
 Cross Section Results Downstream of SR 14.

The Gibbons Creek channel below and downstream of the SR 14 Bridge is prone to sedimentation during storms. Sediment conditions are known to change significantly after storms as well as after sediment dredging episodes. 1971 as-constructed and current channel (October 2015 surveyed) conditions below the SR 14 Bridge are compared in a technical memo describing general risks to SR 14 (ESA 2016). The bridge was designed to convey a 50-year flow (cited as 894 cfs) at a water surface elevation of 33.9 feet NAVD88. The current channel bottom has aggraded over two feet relative to as-constructed conditions due to the diversion structure (see Figure 11, ESA 2016). Deposition after storms can add an additional foot of deposition to the current condition, resulting in three or more feet of sedimentation below the bridge.

Note: Existing RS 1587 and Proposed RS 1559 are approximately the same location.

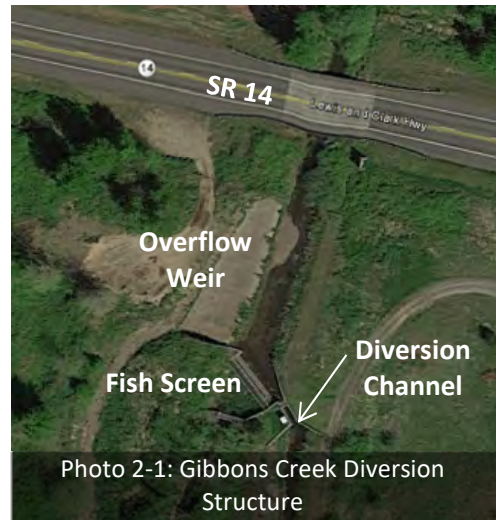
Photo 2-1: Gibbons Creek Diversion Structure

The USFWS operates and maintains the Gibbons Creek diversion structure and Highline Canal. During storms, bedload and debris from the creek are commonly deposited within the structure. The sediment and debris then cause even modest flows (less than 70 cfs) to spill into the lateral overflow and remnant Gibbons Creek channel where they must be pumped through the levee to the Columbia River¹. Regular debris accumulations result in significant pumping costs (up to \$100,000 per year in electrical costs

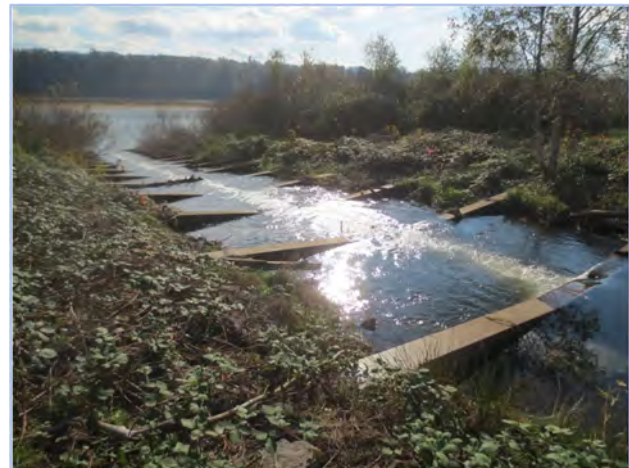
Photo 2-2: Gibbons Creek fish ladder looking south.

The fish ladder (**Photo 2-2**) at the downstream end of Gibbons Creek is also perched two to three feet above the Columbia River during low Columbia River stages, which typically coincide with upstream migrations of lamprey and Chinook and coho salmon. The ladder is also designed with hydraulic drops (jump heights) that exceed 1 foot, which does not meet current adult or juvenile fish passage criteria.

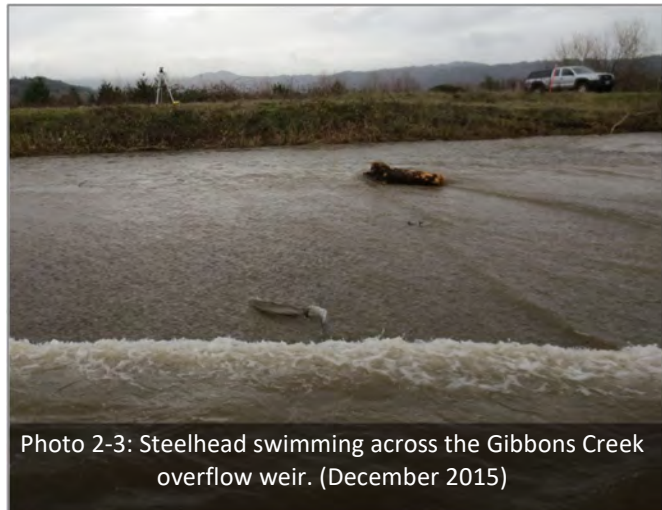
Photo 2-3: Steelhead swimming across the Gibbons Creek overflow weir. (December 2015)

Although use of the fish ladder has not been documented, migrating species such as adult and juvenile coho and steelhead, Pacific lamprey, and largescale sucker (*Catostomus macrocheilus*) were observed in Gibbons Creek during spawning ground surveys and out-migrant salmonid trapping surveys by USFWS (Barndt et al 2003). Some fish may still pass through the tidegates.
